**EVALUATION OF AIRCRAFT WINDSHIELD MATERIALS
IN A SIMULATED SUPERSONIC FLIGHT ENVIRONMENT**

J.B. HOFFMAN
Douglas Aircraft Company
McDonnell Douglas Corporation
3855 Lakewood Boulevard
Long Beach, California 90846

JUNE 1979

TECHNICAL REPORT AFFDL-TR-79-3058

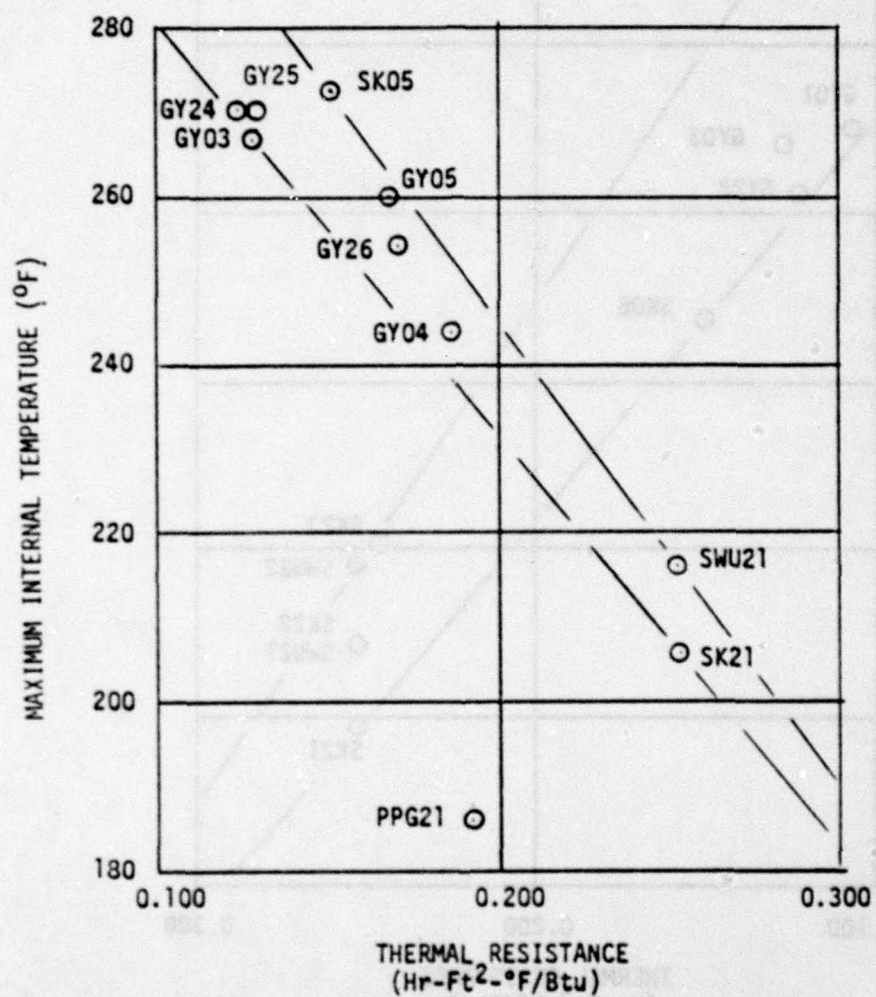
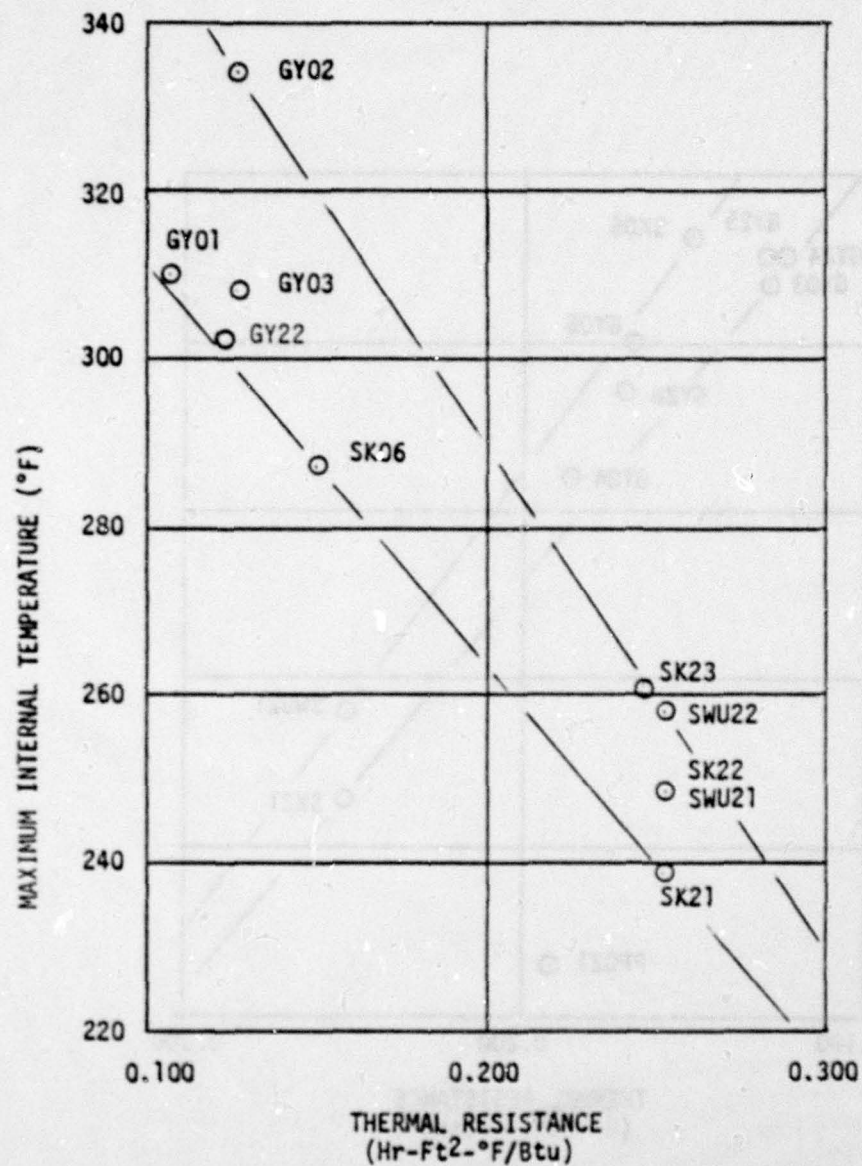
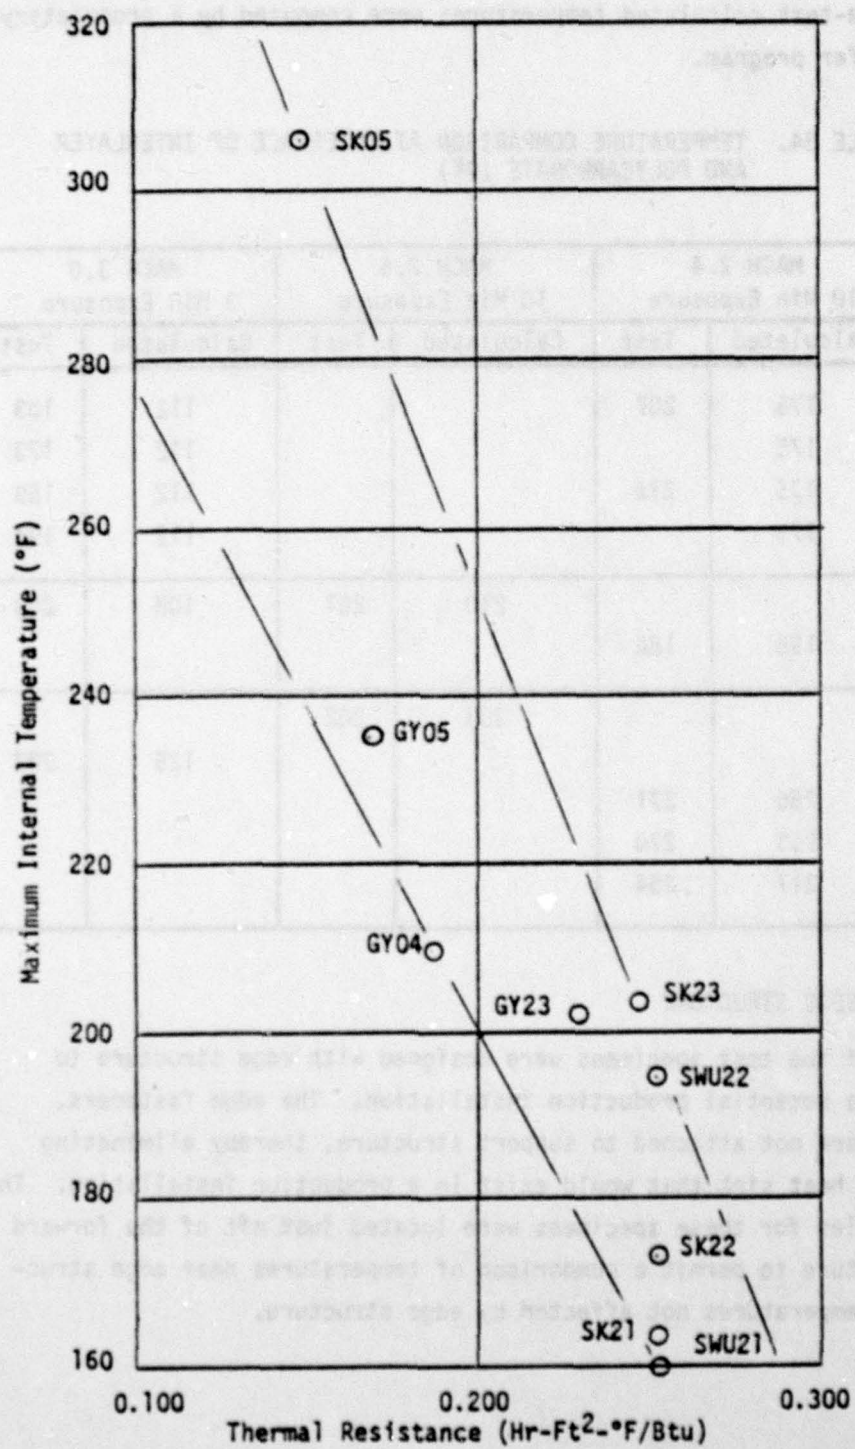
The ratio of temperature to thermal resistance (face ply plus interlayer) is shown in Figures 101, 102 and 103 for Mach 2.4, 2.6 and 3.0. The range of temperatures broadens as the Mach numbers increase.

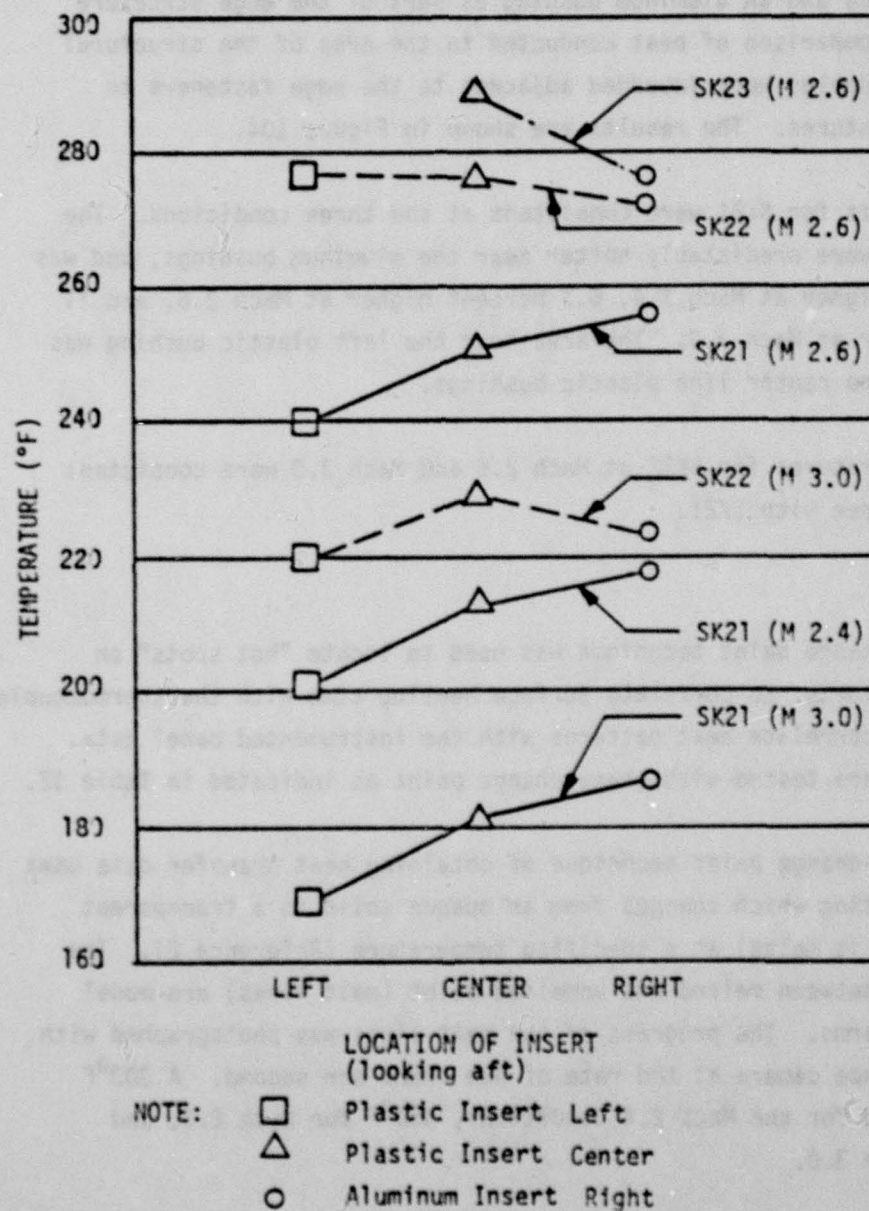
Figure 104. Maximum Temperature at Interlayer/Polycarbonate Interface Adjacent to Forward Inserts.

Certain specimens fabricated by Sierracin were assembled with a plastic bushing and an aluminum bushing as part of the edge structure to permit a comparison of heat conducted to the area of the structural ply. Thermocouples were imbedded adjacent to the edge fasteners to record temperatures. The results are shown in Figure 104.

The results for SK21 were consistent at the three conditions. The temperatures were predictably hotter near the aluminum bushings, and was 8.5 percent higher at Mach 2.4, 6.7 percent higher at Mach 2.6, and 11 percent higher at Mach 3.0. The area near the left plastic bushing was cooler than the center line plastic bushings.

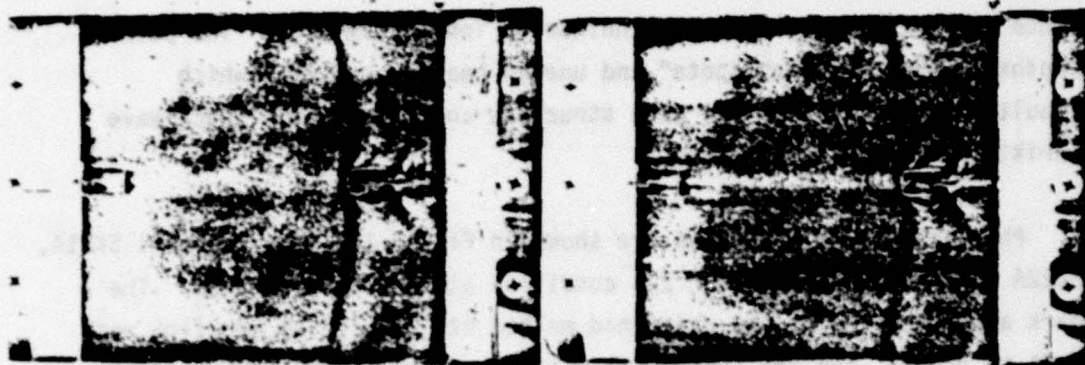
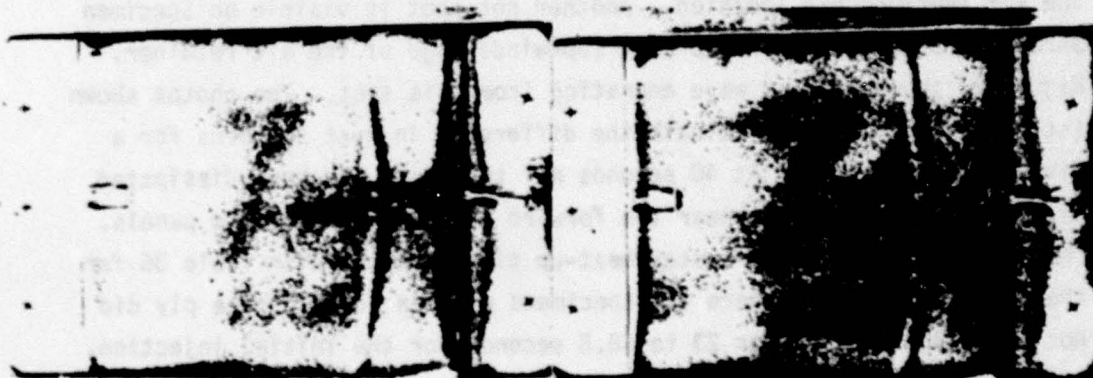
since the uncertainty in the technique is inherently high. The paint photos do indicate "hot spots" and uneven heating patterns which resulted primarily from the edge structure and also from a shock wave striking the specimen surface.

Phase-change paint photos are shown in Figure 105 for Specimens SK21A, SK22A and SWU22 for the Mach 2.4 condition at 25 and 30 seconds. The dark areas show where the paint had melted at 300°F. The air flow was left to right. The arc (hot spot) visible on the right side of each photo was caused by the interference shock visible in the shadowgraph photos shown previously in Figure 30. The shock impacted the panels at the aft thermocouple location. Another hot spot is visible on Specimen SK22A and SWU22 along the forward (up-wind) edge of the aft retainer. Figure 30 shows a shock wave emanating from this spot. The photos shown (at 25 and 30 seconds) indicate the difference in heat patterns for a five second interval. At 40 seconds all the paint had been dissipated except for slight traces near the forward (up-wind) end of the panels. These results indicate a faster heat-up time than shown in Table 36 for the thermocouple data where the specimens with an acrylic face ply did not reach 300 degrees for 23 to 58.8 seconds for the initial injection.

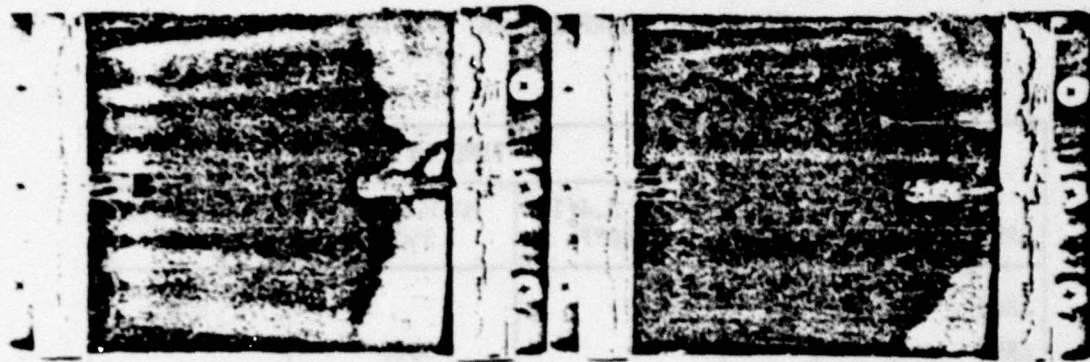
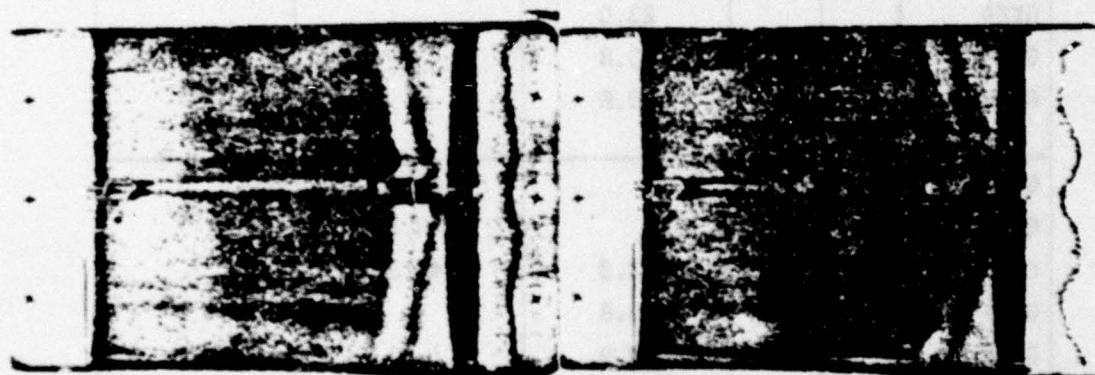
Figure 106. Thermal Paint Injections at Mach 2.6.

Figure 106 shows specimens SK21A and SK22A for the Mach 2.6 condition at 35 and 40 seconds. These specimens had been coated with a paint that would melt at 350°F. Shock wave patterns are visible, as well as a hot spot along the retainer on Specimen SK22A. The paint was completely gone after 45 seconds of exposure. The dark area in the center of the specimens indicates a high temperature area. Table 36 shows a faster heat-up time for the acrylic material than for the urethane material, indicating that urethane dissipates heat quicker than acrylic.
